Remaining Life Evaluation of Coke Drums

Richard S. Boswell, P.E
Stress Engineering Services Inc, Houston

Tom Farraro
Michael J, Sober
CITGO Petroleum Corporation

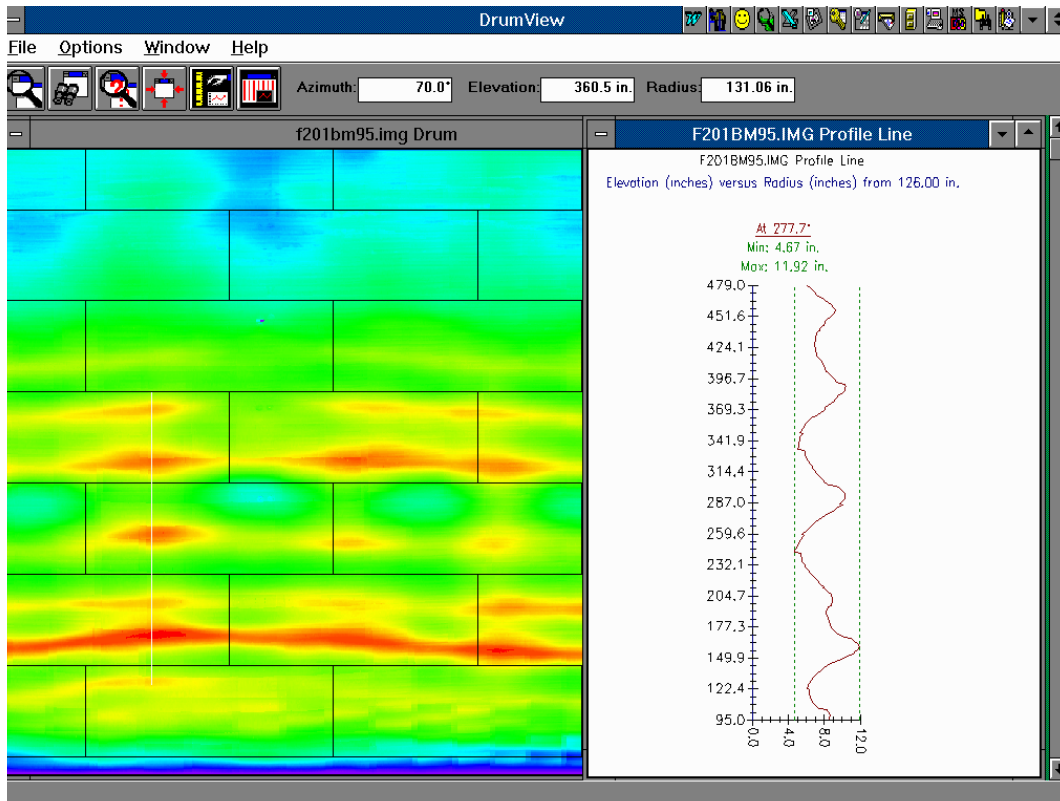
Figure 2: Profile scans will determine strain gage location, and be used in finite element model.

1. The bulging was greater than 10% of the original dimension, and was essentially uniformly banded though out the elevation of the coke bed. There was measurable growth in a six month interval. This is demonstrated in the profile of Figure 2.
2. The typical stress range for each cycle was 50.1 Ksi in a material with 32 Ksi yield. History of loading demonstrated that occasional cycles generated significantly higher stress. These are considered to be damage accelerators.
3. Shell thinning above and below each circumference weld was significant (15%) and represented a necking down (Poisson contraction) associated with tensile failure.
4. Numerous small circumferential cracks were appearing to link and form larger cracks as a result of axial stress.

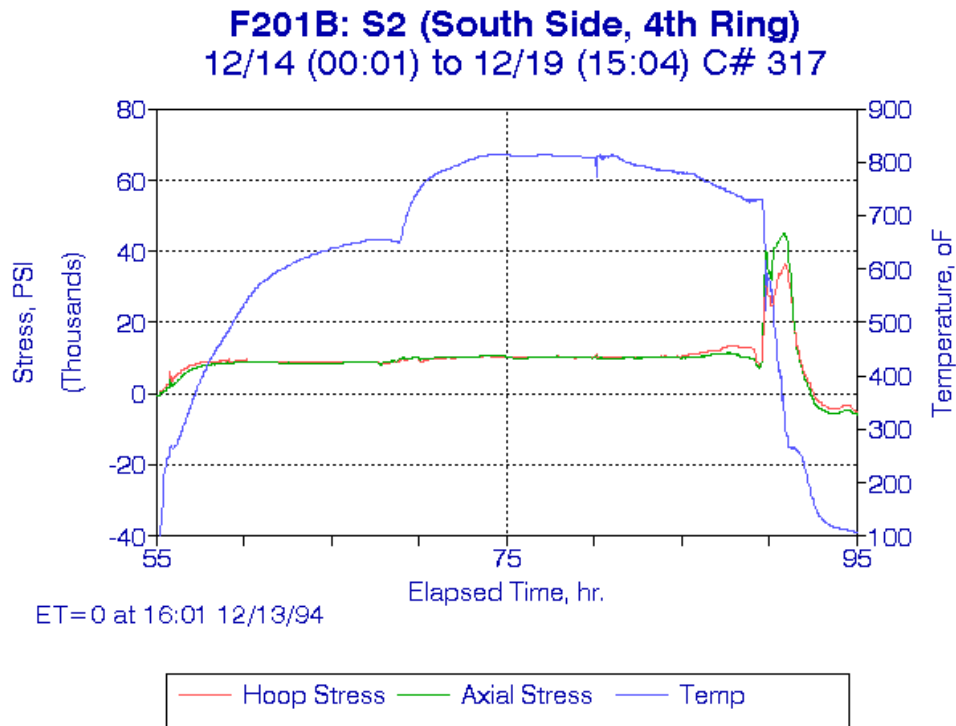
Figure 3: Large stresses are generated during the quench. A typical coking cycle is shown.

The design details are appropriate for a vessel deigned as a pressure vessel with a safety factor relative to burst. Figure 3 shows how this vessel actually operates in a coking cycle by plotting stress from strain gage measurements versus time. This location was placed 6 inches below the seam weld. A higher than normal stress is created during product fill because of the corrugations in the wall. At the conclusion of the cycle, the drum is switched with its mate, and water preceded by steam is input through the lower cone. As the water level rises, the drum and coke mass is cooled and quenched. A large stress develops and then releases.

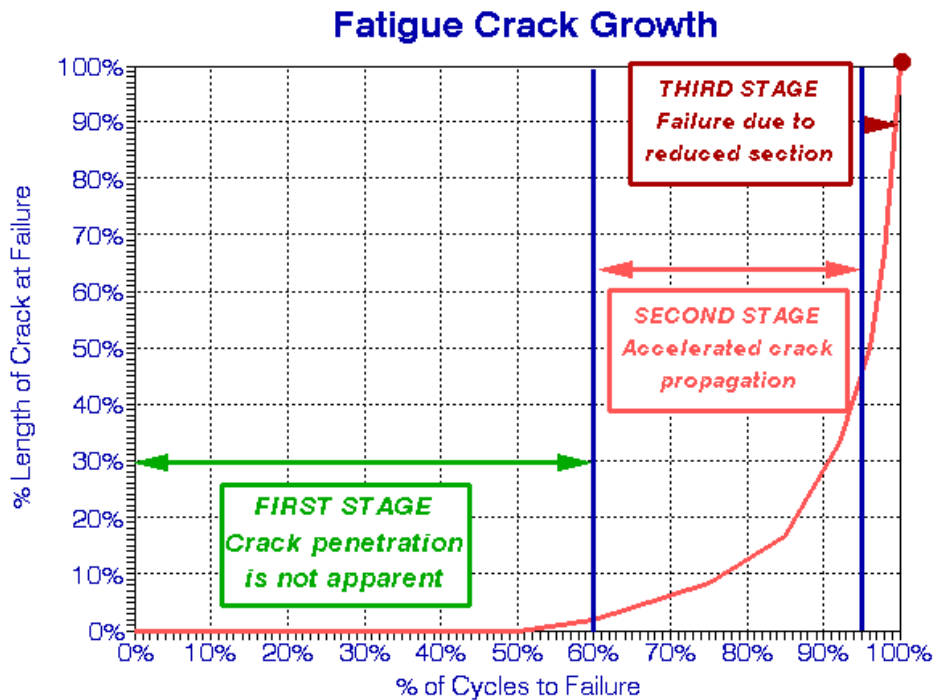
Figure 7: Three Stages of Fatigue Crack Growth. Operation beyond 95% Cyclic Life or 50% of Critical Length requires Plant Engineering, Operations, Design & Reliability Symposium

diligent inspection and repair.

Low Cycle Fatigue is considered the failure mode for cyclic service coke drums. Life is based on a number of cycles of operation at specific stress ranges, and not as a function of time to failure⁴. Figure 7 illustrates the three stages of fatigue failure⁵. During the first stage, crack development is not observable and penetration is not detected. From approximately 50% to 95% of the cyclic life, cracks will incrementally grow to half of their final catastrophic size. During the third and final stage, crack growth is rapid because of reduced cross section created by crack penetration through the thickness and around the circumference. ***Continued operation beyond 95% of the cyclic life is very dependent upon the inspectors ability to find and measure the crack, and upon the successful repair of those cracks which have reached half of their critical size.***

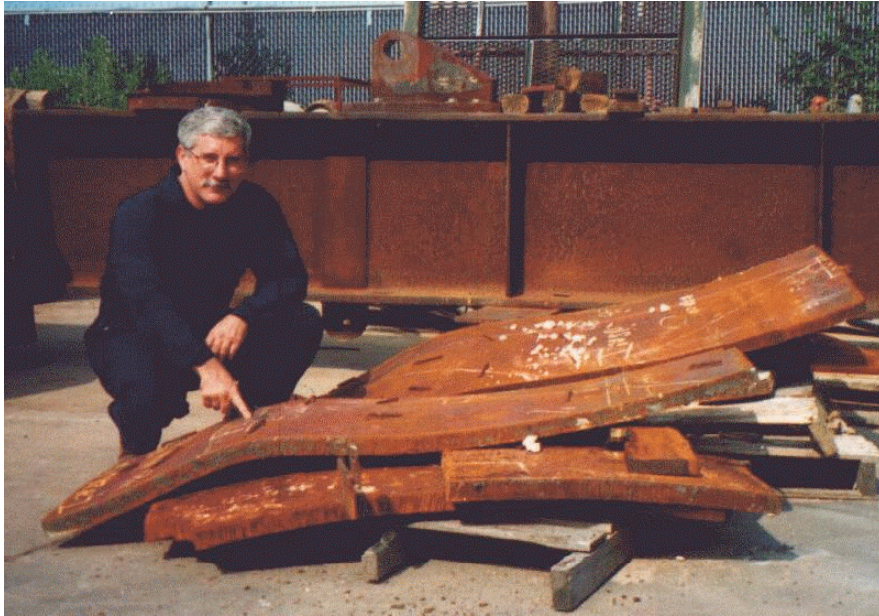
Figure 8: Dramatic examples of plate removed from drum demonstrate magnitude of bulge.

An extensive review of the structural integrity was performed for the aged Coker I F-201 drum, in service for 28 years with 5,500 accumulated cycles. Inspection data was combined with strain gage measurements and finite element analysis methods to provide a fact based decision process. Management determined that further operation until replacement drums could be installed was not economically viable. The lower portion of two of the drums were replaced. Figure 8 shows samples of plate removed for testing and metallurgical inspection. The extent and magnitude of this fully circumferential bulge is dramatic and reduces the capacity of the vessel as a pressure vessel. This geometry also accelerates fatigue loading by increasing bending stress.

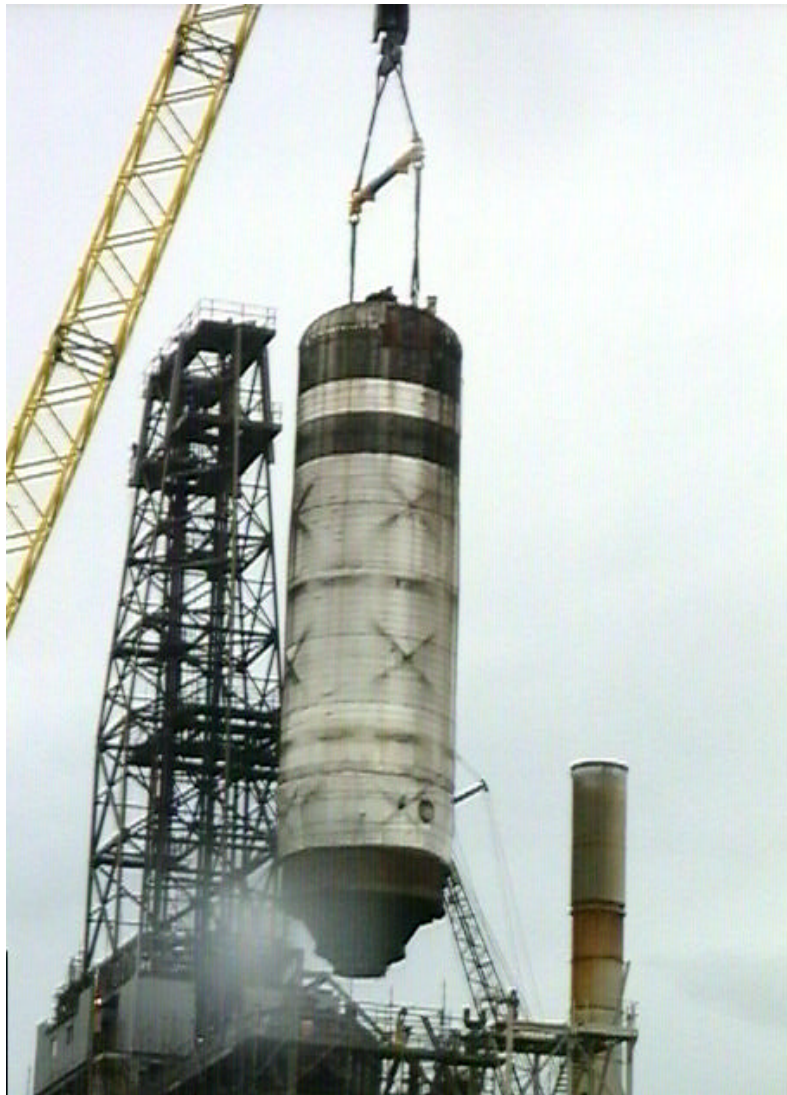
Figure 9: Removal of repaired coke drum which operated without problem until new drums were installed.

The other two remaining drums continued to operate with strain gages monitoring them in a similar manner. During the final three months prior to replacement, they were routinely inspected and repaired at two week intervals. The other two repaired drums operated without problem. Figure 9 shows one of the repaired drums as it was removed after 28 years of service.
