ETCE 99 - Symposium on Plant and Facilities Reliability and Mechanical Integrity

Assessing the structural integrity and remaining life of Coke Drums with Acoustic Emission Testing, Strain Gaging, and Finite Element Analysis

Claudio Allevato, ASNT AET LIII – Stress Engineering Services, Inc. – Houston, Tx Richard S. Boswell, P.E. – Stress Engineering Services, Inc. – Houston, Tx

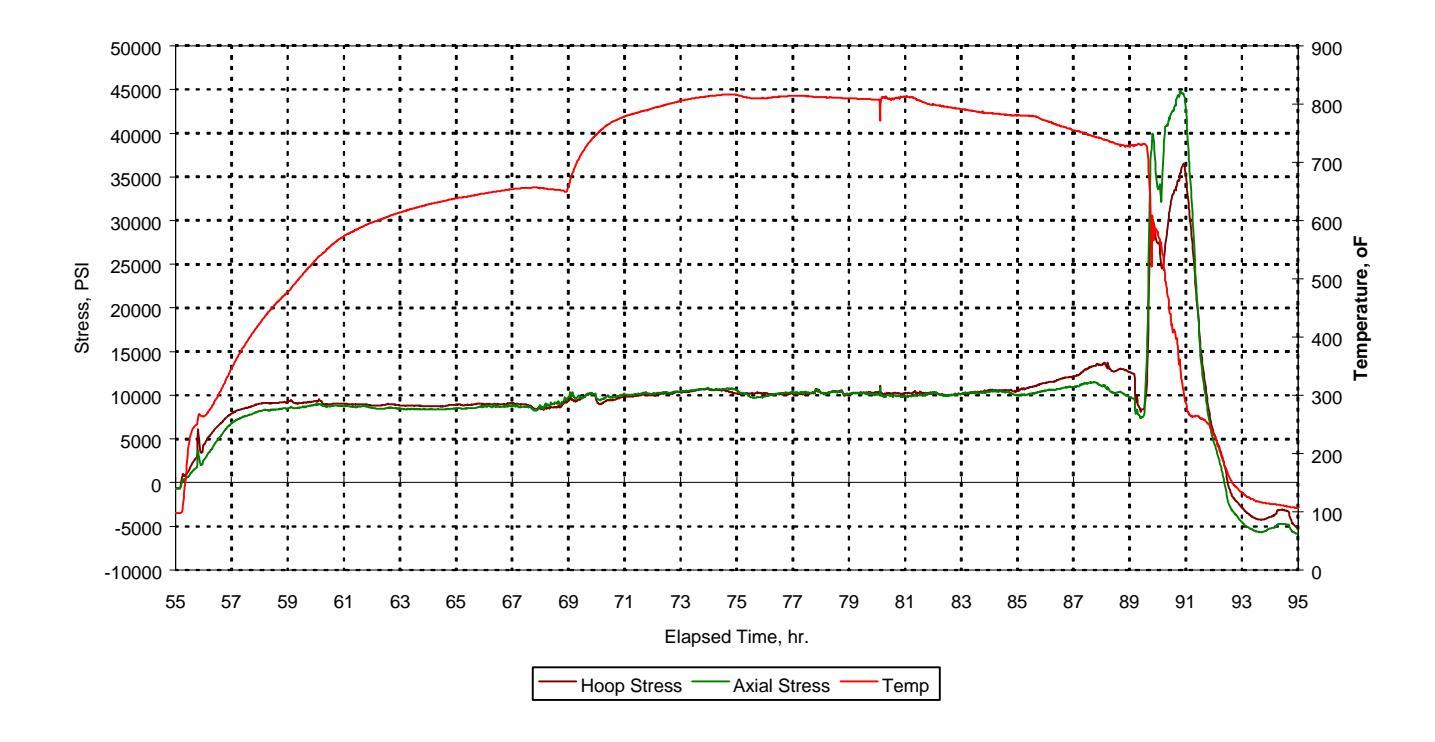
Figure 1: An example coking cycle with stress measured near a bulge in 1994.

A typical coker cycle in terms of temperature and stress is illustrated in Figure 1. A unique feature observed globally throughout the drum is the short term increase in stress during quench as the drum is cooled, followed by a release of the stress usually midway through the quench. This result will vary from cycle to cycle. Older vessels nearing end of useful life are often distorted with bulges and permanent growth of the shell. This geometry increases the problem through several mechanisms contributing to low cycle fatigue. In general, through wall cracking develops near the circumferential seams

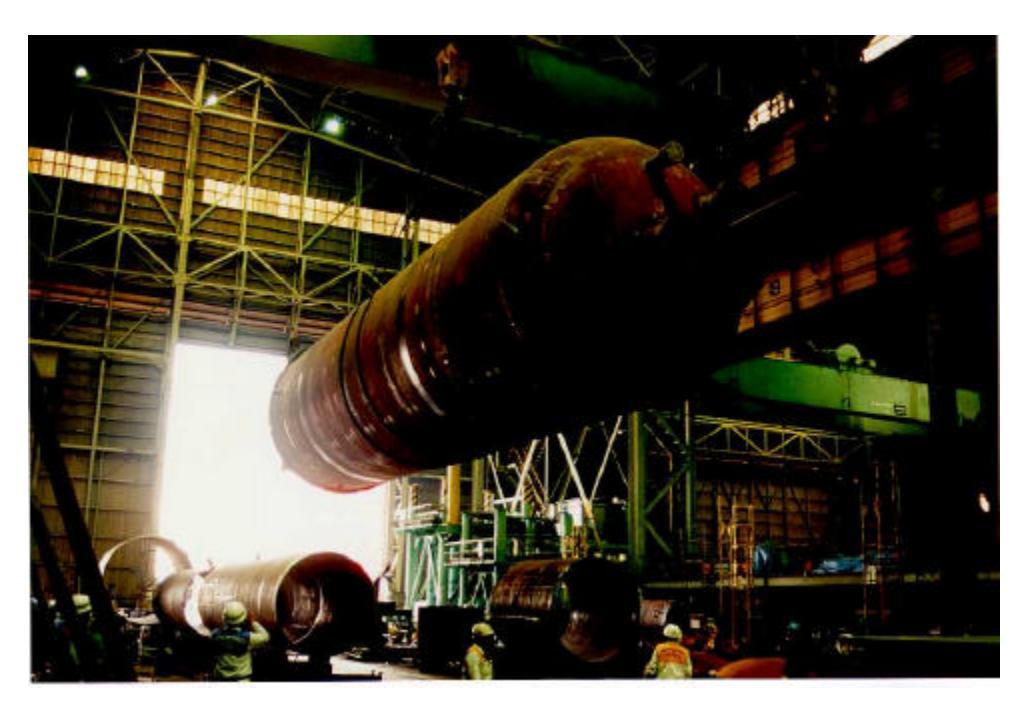
Figure 2: New coke drums to be tested with Acoustic Emission during fabrication.

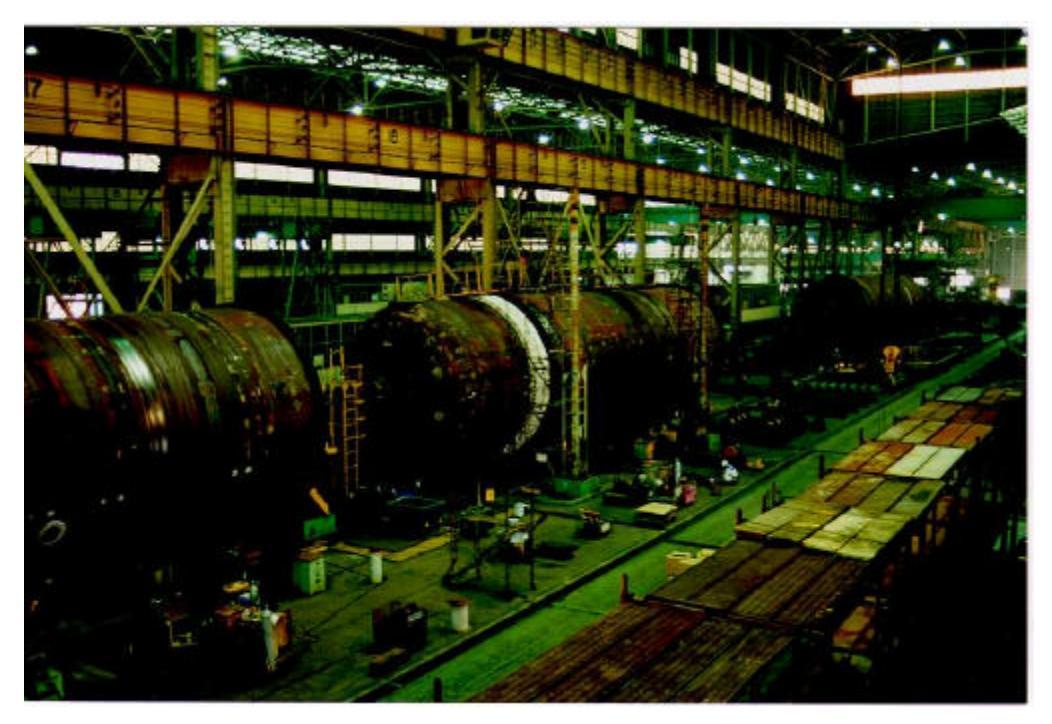
Figure 3: AE tests during special hydrotesting of new drums assured the client of fabrication integrity.

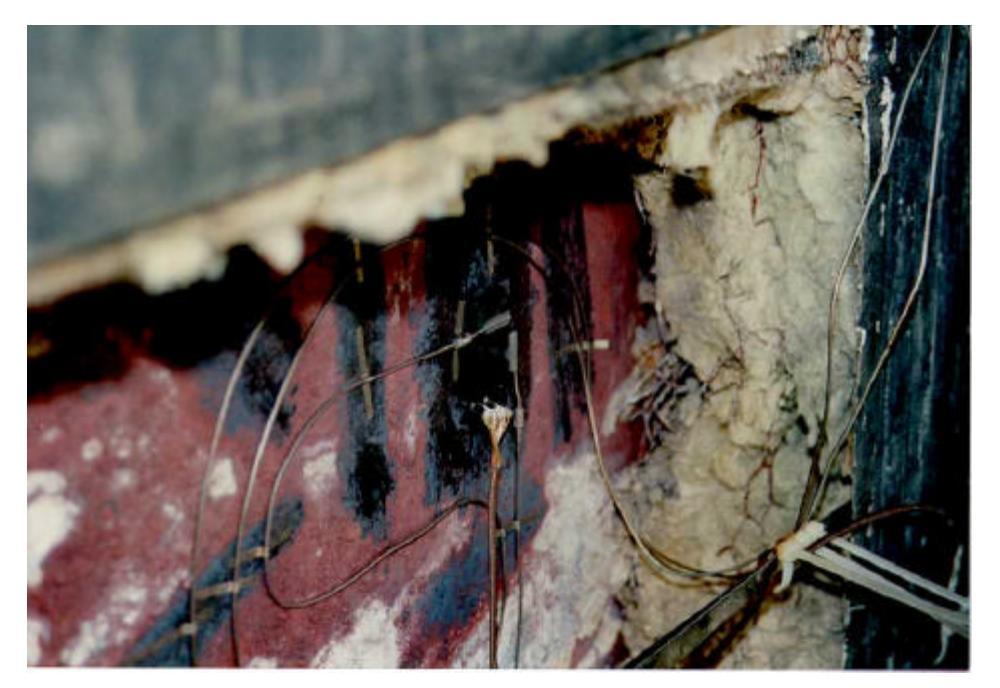
Figure 4: Hoop and Axial strain gage installed on a coke drum. Insulation is replaced during operation.

Figure 4 shows a typical installation of 2 strain gages on a drum (hoop & axial) with their companion thermocouple.

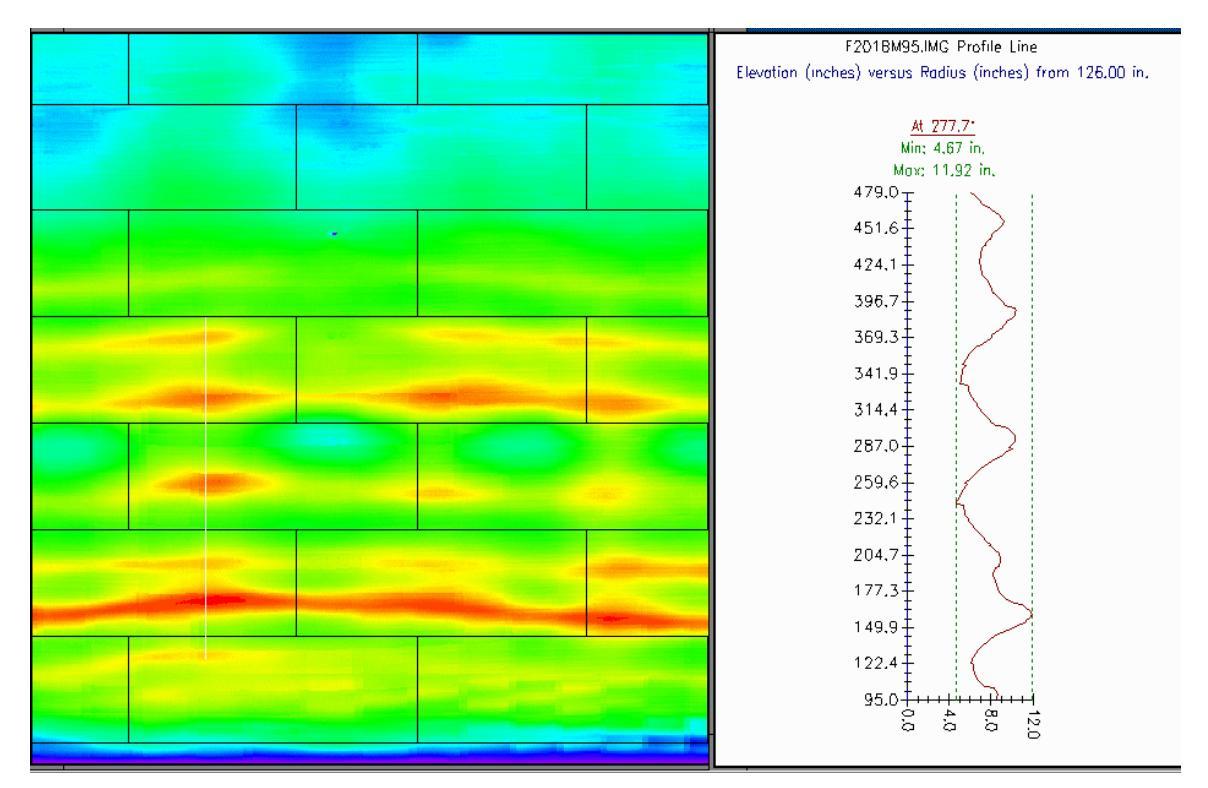
Figure 5: Radius profile of 22' diameter coke drum after 5500 cycles.

Figure 5 represents an aged, corrugated coker shell radius as measured with a laser scanning system. The color contour represents the drum radius, which in this case is at least 4" greater than nominal as built, and up to 12" greater than the original 132" radius. In this case, girth weld seams are generally on a minimum bulge diameter, with maximum stresses on the outside surface of the weld. Strain gage locations were placed near these welds, providing conservative high stress measurements. These welds were known to crack from the outside surface.

A simple and effective method of evaluating the influence of bulging in a corrugated vessel is to solve a finite element model with internal pressure loading. The profile data displayed in Figure 5 is easily exported in a format, which can be used for finite element geometry. Figure 6 displays such a model using 3-D shell elements capable of providing membrane and bending stress. An internal pressure load will create local stress gradients due to ring bending and an extension of the bulge. Stress contour results indicate locations with highest stress and these will be the most likely candidates for crack propagation. Figure 7 is an example of stress plots. Other loadings can be applied to the model such as local and global thermal gradients, and coke crushing due to radial interference.

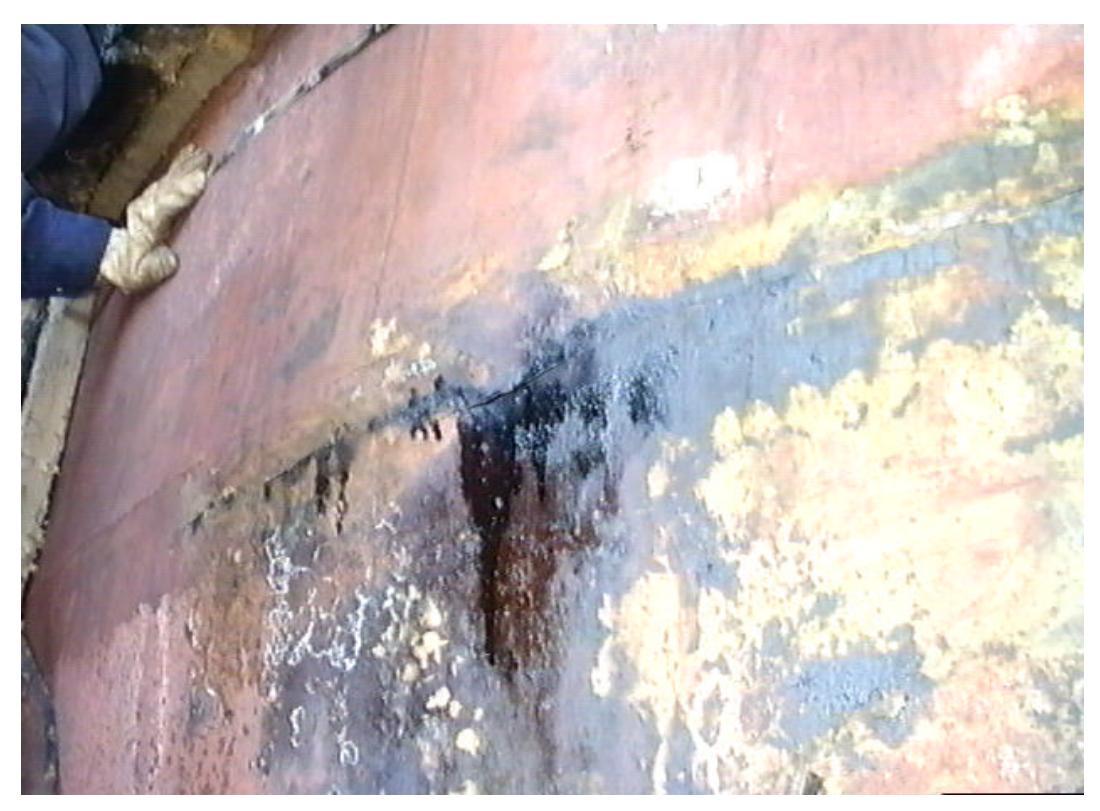
Figure 6: A crack detected during fill with hot oil in 27' drum.

Other drums have been measured with locations near welds that were on the maximum diameter of the bulge. These bulges are typically shorter in width and depth, and create a maximum stress on the inside of the wall. This condition creates cracks from the inside with sudden unanticipated leakage to the outside. Figure 6 and 7 are examples of such a through-wall crack on a 27' diameter drum, and Figure 8 is a view of a similar seam from the inside.

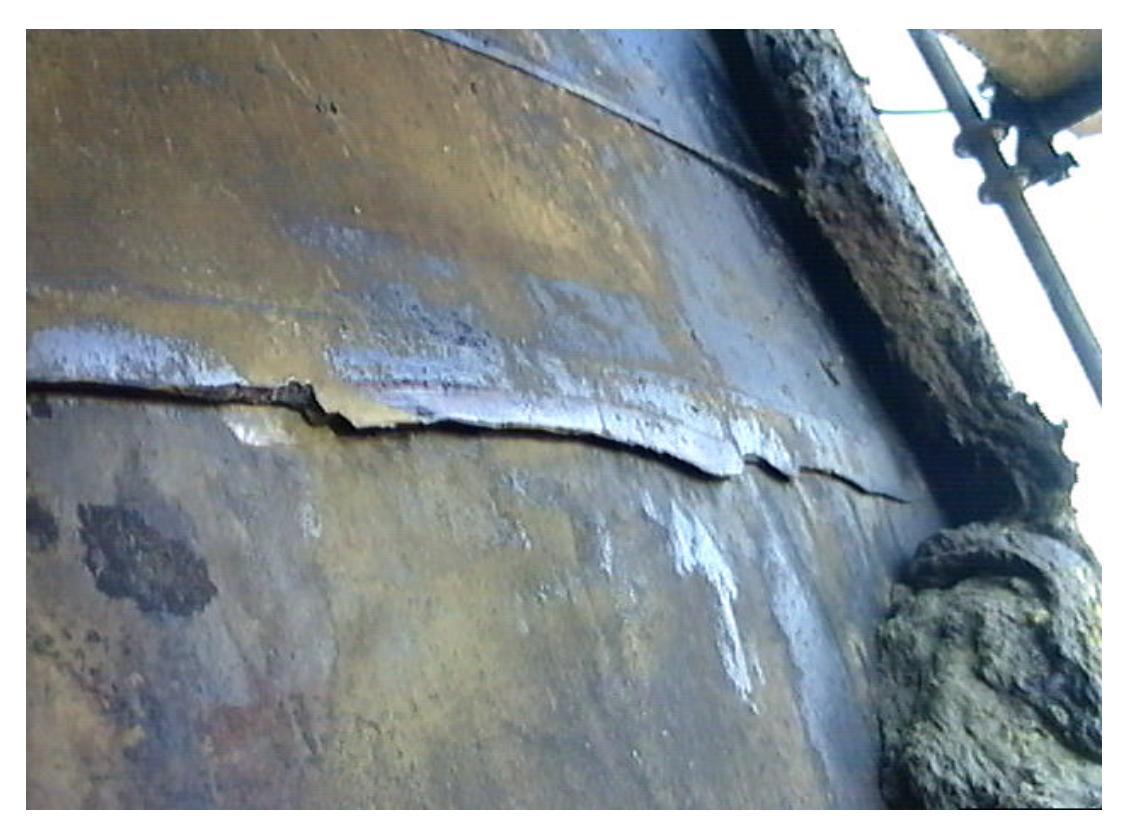
Figure 7: A larger crack developed in 27' drum during quench after repair from outside.

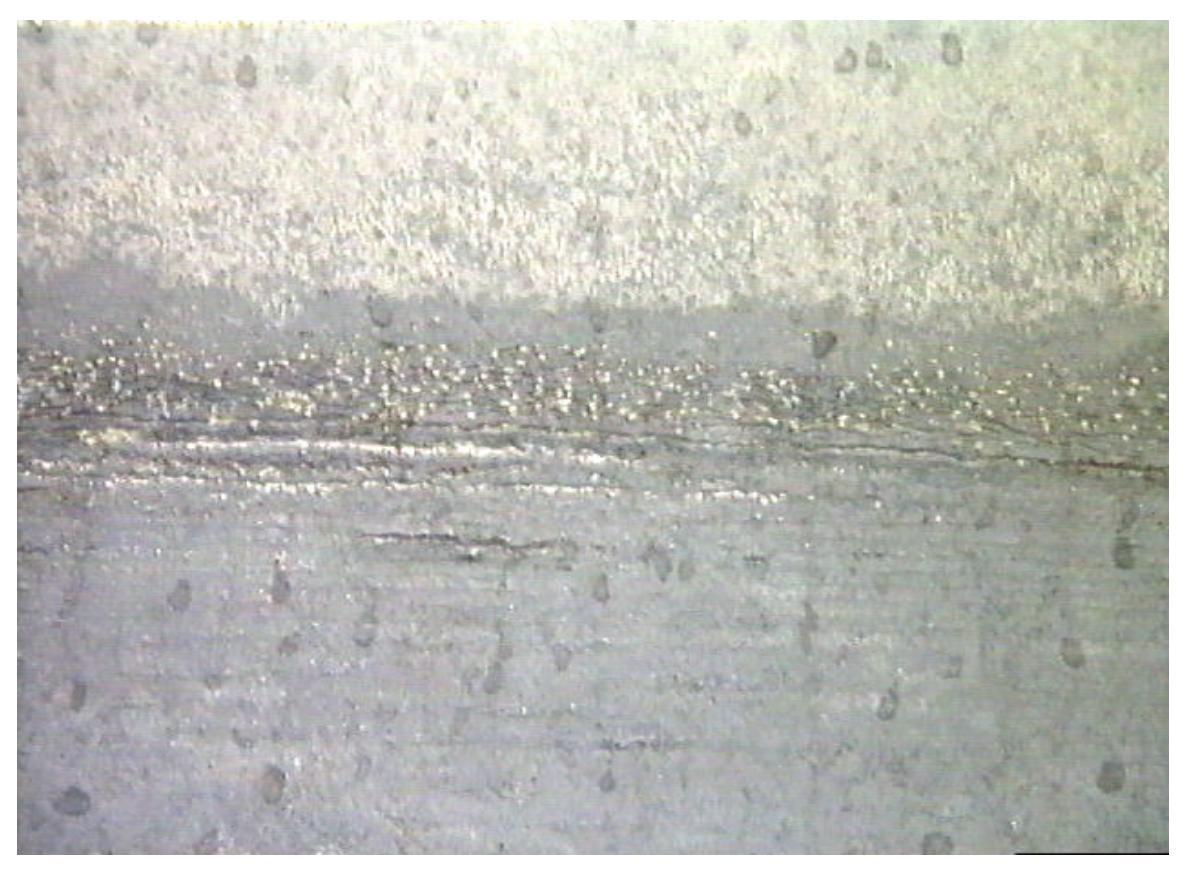
Figure 8: Typical cracking on all girth seams inside the 27' diameter drum.

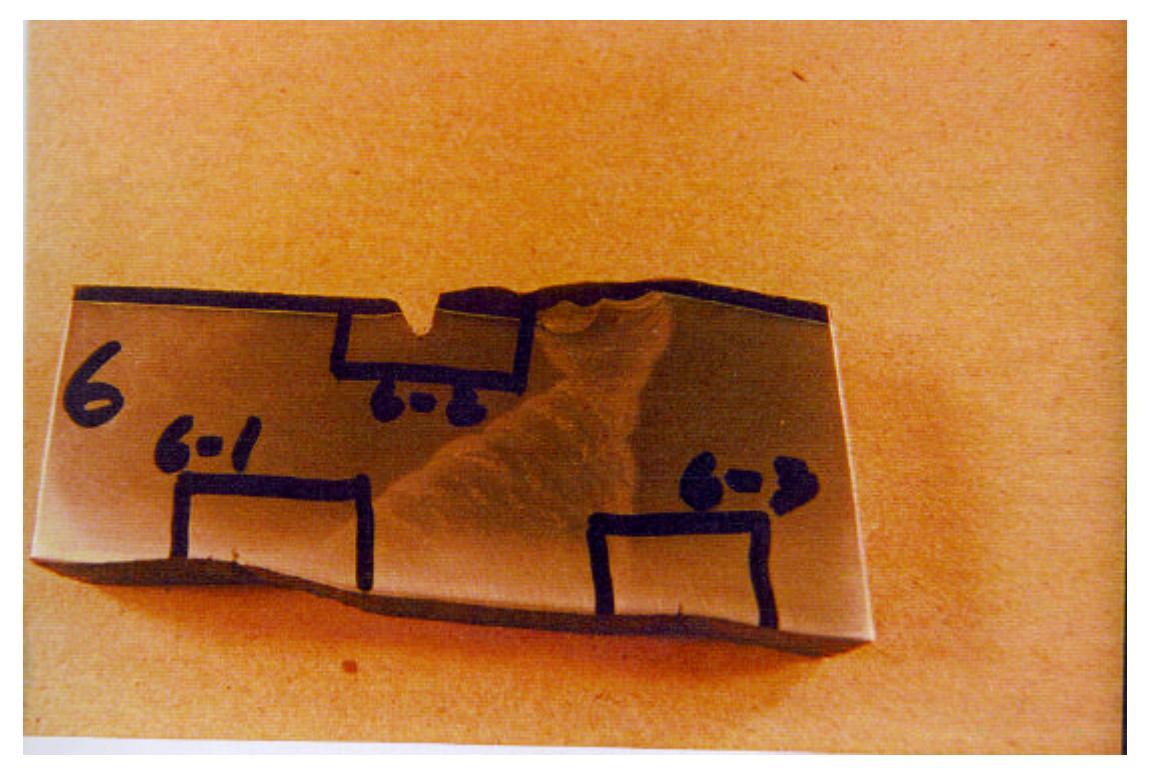
Figure 9: OD cracking is visible on either side of girth weld, and a large crack is present on the ID through the cladding. Sample taken from 22' diameter drum.

Although coke drums are designed with the rules of ASME Section VIII, Div 1 pressure vessels, they typically fail from low cycle fatigue at the skirt and at circumferential shell seams. Vertical seams rarely fail. Crack formation suggests very high axial stress acting across the weld. Strain gage measurements on corrugated drums have shown that a high stress develops during quench as cooling increases up the drum. The maximum stress is achieved midway during the cooling and then releases. This stress is generally large enough to create low cycle fatigue failure which appears at the weakest points of the vessel, typically weld seams with defects and undercuts, combined with bi-metallic weld construction. A typical sample removed from a 22' diameter drum is shown in Figure 9. This sample shows small OD cracking on either side of the weld, and a very large defect on the ID.

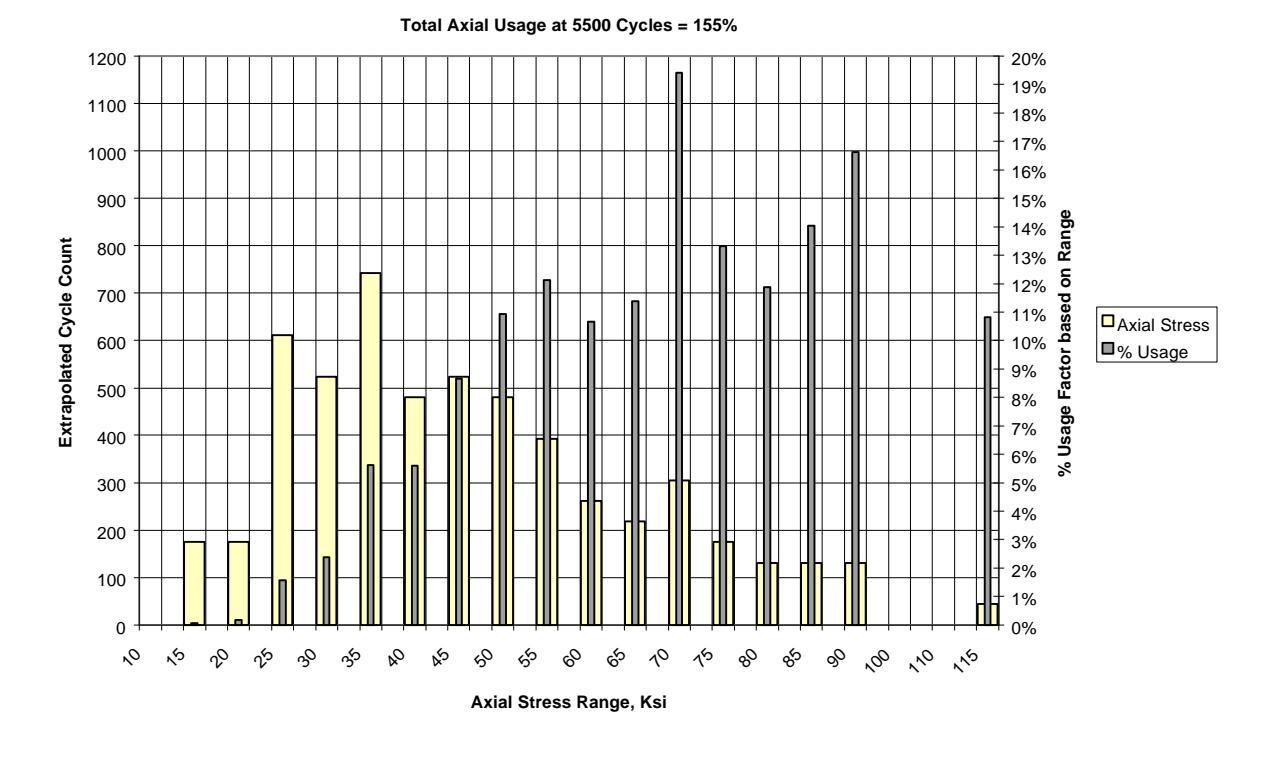
Bulged Drum Axial Stress Range

Figure 10: Histogram of axial stress range measured on 22' diameter drum.

Figures 10 and 11 show stress histograms extrapolated from 126 measured cycles. Also included on these plots is the Usage Factor (as %) attributed to each stress range. The Usage Factor as used by the ASME Code is a Miner's Rule summation of the damage accumulation. For each stress range, the Usage Factor is a ratio of the number of occurrences per number allowed by the fatigue curve. This is also known as the Damage Accumulation Rule. For a vessel design, these ratios should sum to less than unity. This is traditionally evaluated with alternating stress ranges. However, better correlation with actual failures has been observed when the full stress range is used, removing some conservatism of the design curves.

In these examples a large axial damage accumulation is shown (1.55) as a result of bulge influence. The hoop stress damage is less sensitive to bulge interaction and slightly exceeds unity. This demonstrates that once bulges begin to form, the increase in axial stress will encourage cracking of the circumferential seams.

The large stress ranges at the extreme right can be attributed to local channel flow creating local cooling which stretches circumference of the shell in local tension. For axial stress to be high, bulges are locally contracted to generate this stress direction. As demonstrated in these figures, the extreme stress generate a large percentage of the damage for only a few occurrences. Contributions from coke interaction will be discussed in greater detail in a subsequent paper by the authors.

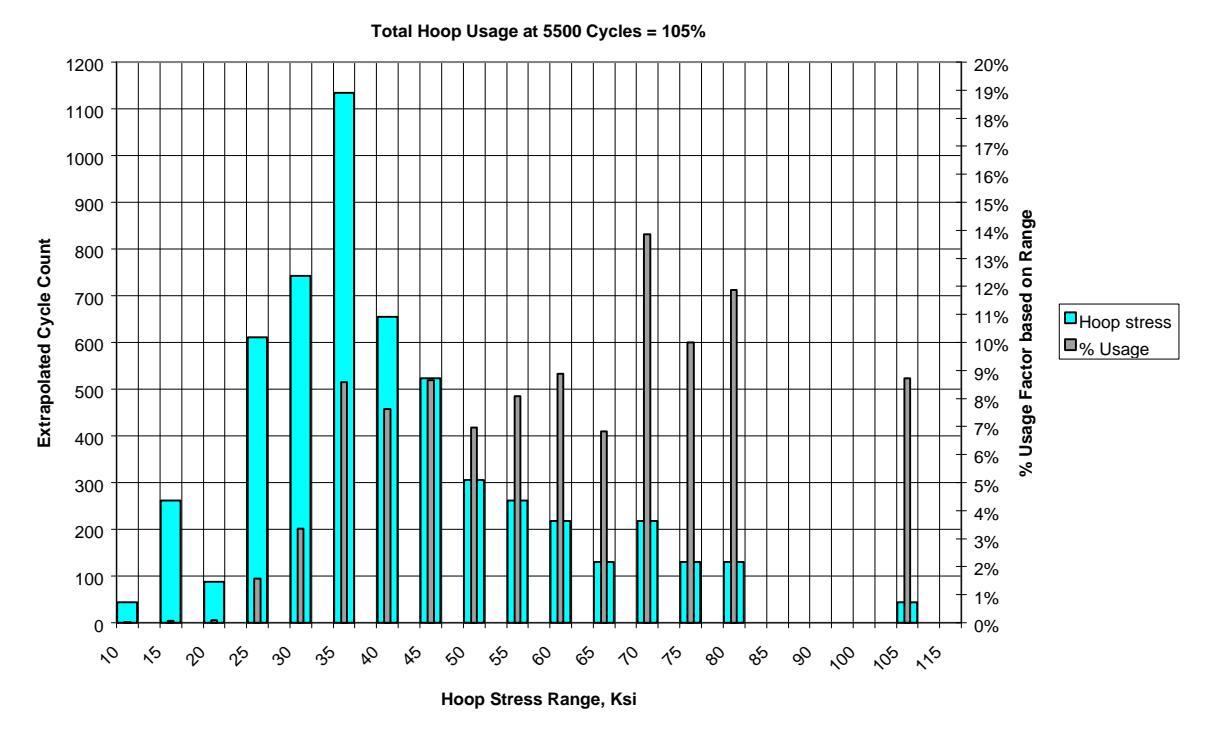
Bulged Drum Hoop Stress Range

Figure 11: Histogram for Hoop Stress range measured on 22' diameter drum.

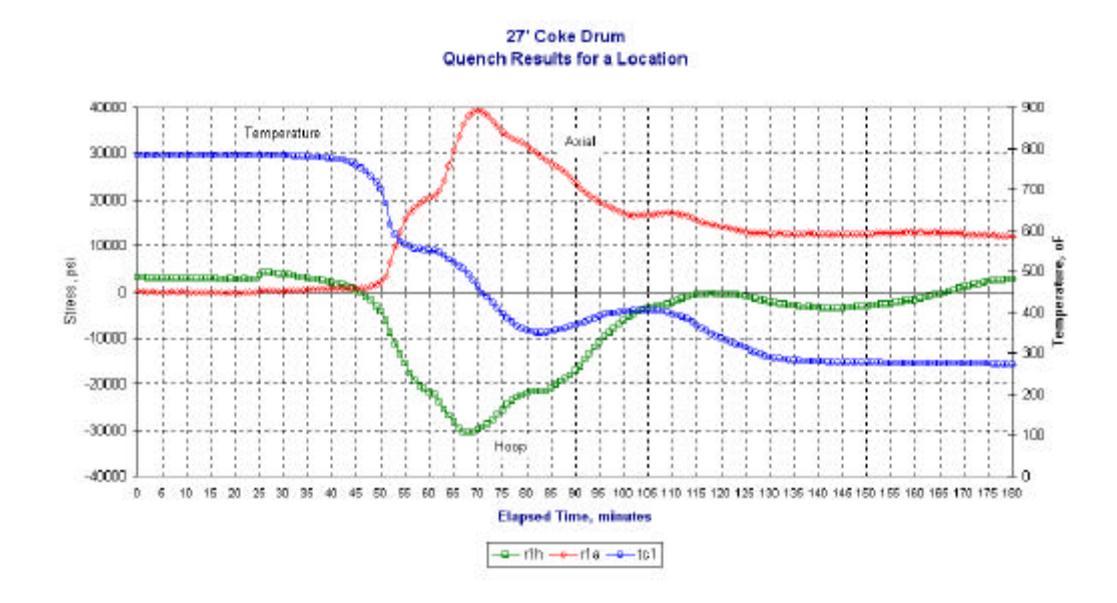
Figure 12: Quench stress on 27' diameter drum shows bi-axial shear.

The necessity for bi-axial strain gages is shown in the typical but interesting measurements recorded on a 27' diameter drum in Figure 12 and 13. Ideally a three gage rectangular rosette could be used to account for actual direction of the Principal Stress. When Hoop and Axial gage placement is used, the inherent assumption is that these are the Principal directions.

These gages were placed near a weld seam centered on a short length bulge associated with cracking from the inside out. Consequently, they are measuring Membrane minus Bending. As the bulge flattens, Axial stress is expected to be lower on the outside than on the inside. In Figure 12 the hoop stress is compression while the axial stress is tension. This is known as bi-axial shear with Stress Intensity equal to the difference in these two maximums, approximately 70 Ksi . Fatigue is usually estimated as a function of the Stress Intensity.

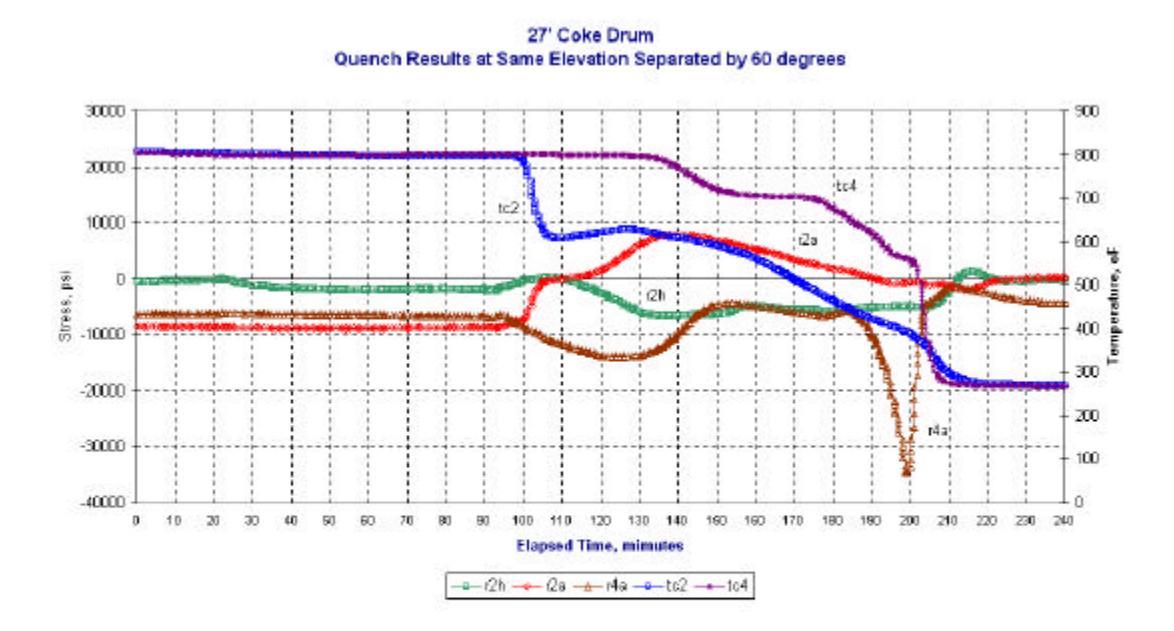
Figure 13: Quench stress on another 27' diameter drum shows delays in cooling at same elevation.

As observed in Figure 13, the quench is not only rapid at the beginning, but can be significantly delayed only 90 degrees around the circumference.

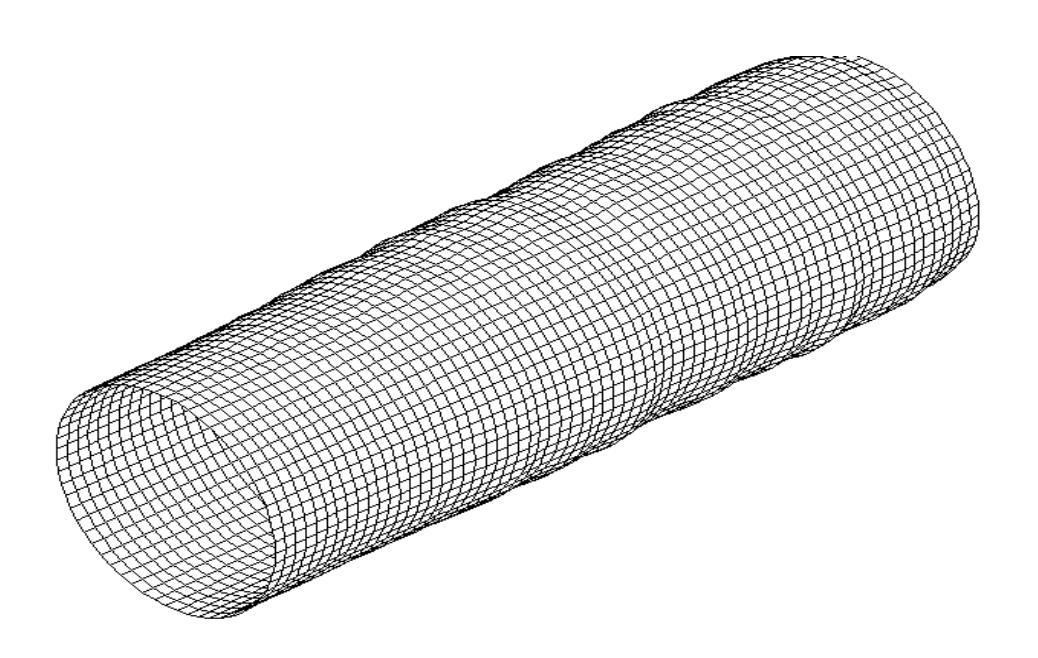
Figure 14: A finite element model created from laser scan contour data dramatically shows the extent of huloing

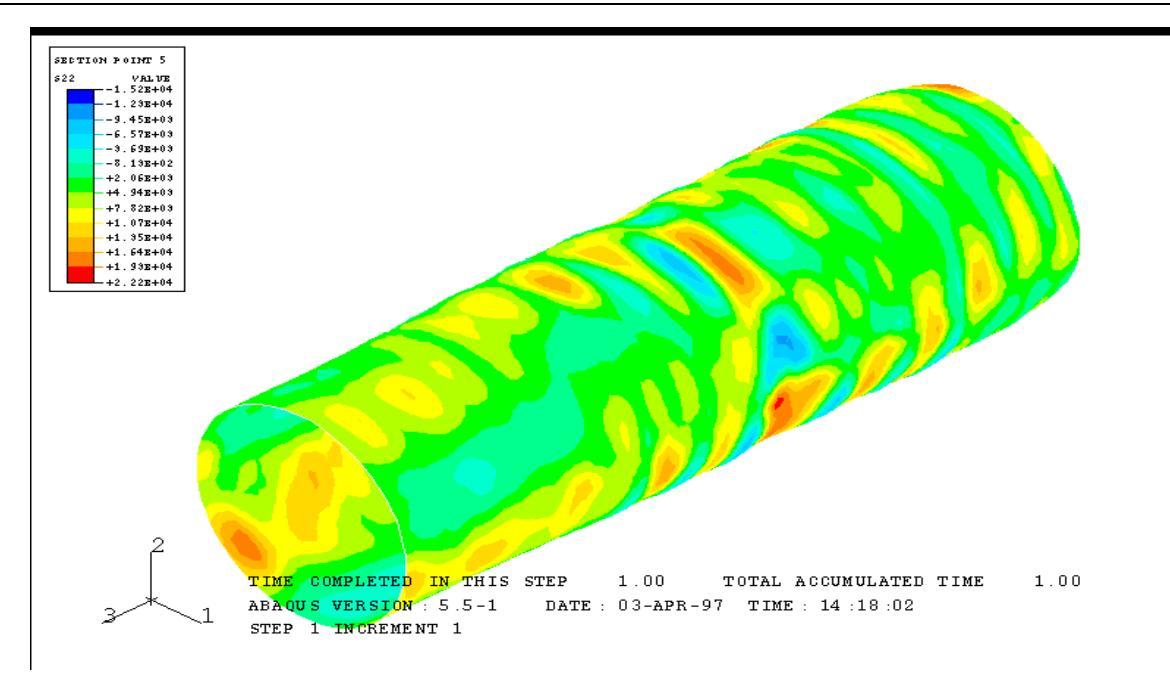
Figure 15: Axial Stress results of analysis indicate most likely areas of crack formation and propagation.

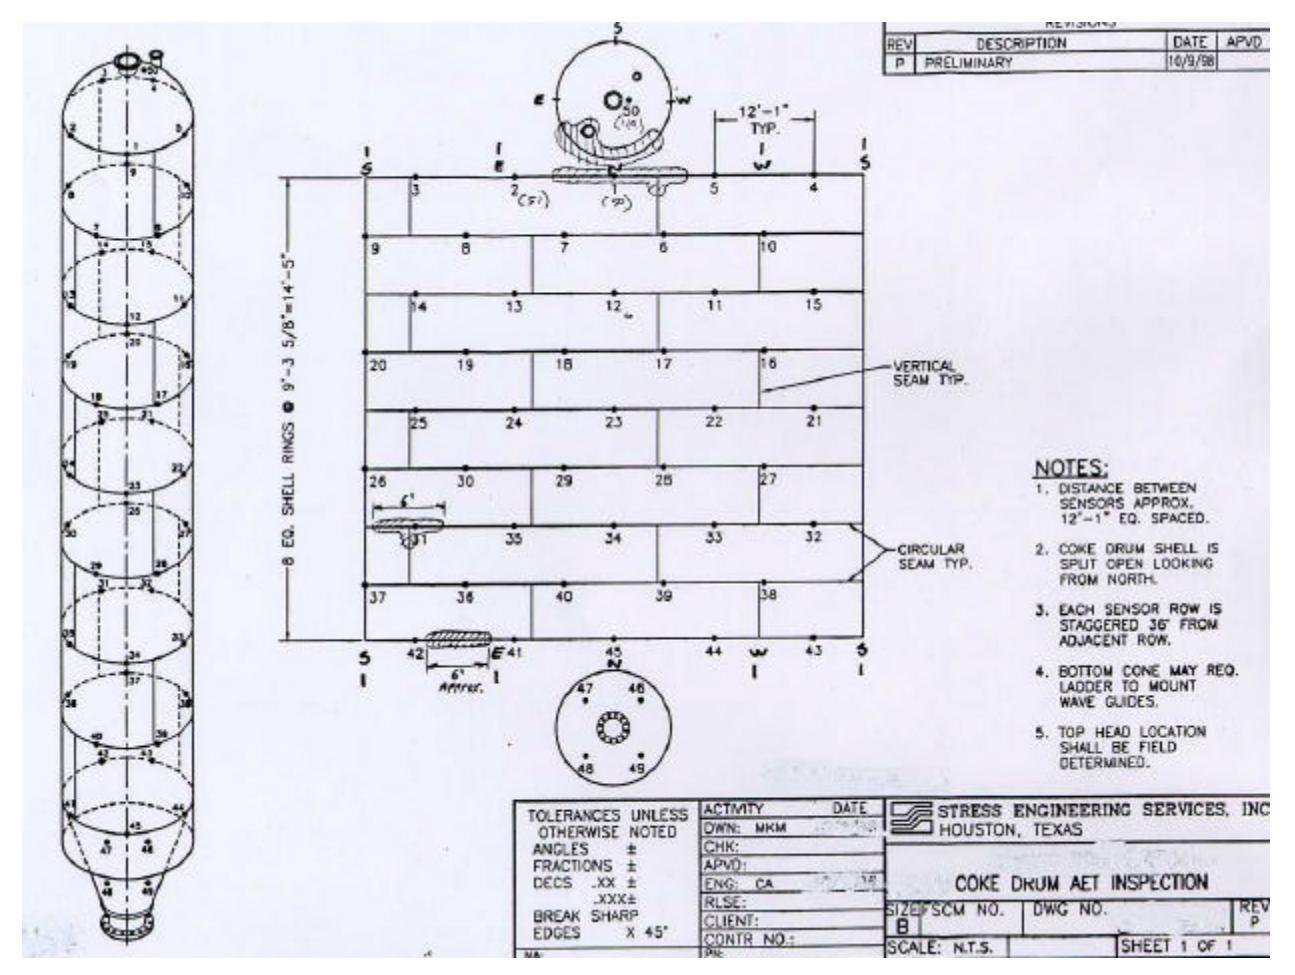
Figure 16: Location of Acoustic Emission sensors for global inspection of a coke drum.

Figure 16 at the end of this report illustrates the distribution of AE sensors over the surface of a typical coke drum. The application of the AET on in-service drums is often accompanied with skin weldable thermocouples. The thermocouples (TC) have an important role on this approach. The TC's produce the temperature trends experienced by the drum's outer surface, both during heat-up and quench. These temperature fluctuations are sometimes very fast. Quench rates of 3000 ⁰F/hour have been documented in the industry. Although very fast, these quench rates last for only a few minutes. Nevertheless, their impact on the thermal stresses imposed on the drum's surface, and across their wall thickness, is significant. Values in excess of the yield strength of typical coke drum materials have been often measured (strain gaging) in the field.
